Property: §§ Chatham Road, London SW11 §§§

Scott Schedule

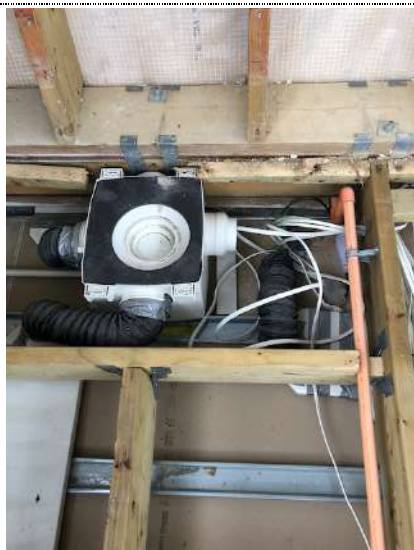
REF: 160620-1

2nd Floor bathroom fan – squashed ductwork, discharge not connected, how is access attained?

Comment: The fan doesn't fit. Squashed ductwork is unacceptable. Why not install a VES Microbox (167 high, 240 wide, 436 long) sorry don't know joist spacing

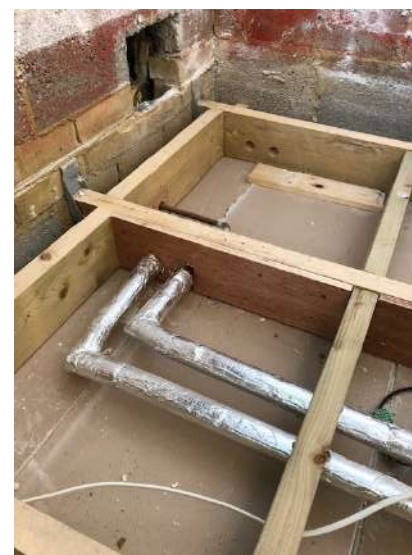
REF: 160620-2

1st Bedroom – air venting problem

This leg caused an air-lock as pipework drops to radiator without a connection above which would have aided air venting. It "should" be possible to use mains pressure to flush out any air lock now that the mains fill point is more accessible but knowing there is an issue here suggest take a small bleed pipe from the top of the dropper (where a vent should have been fitted) into the boiler room with a needle valve and label "air vent"

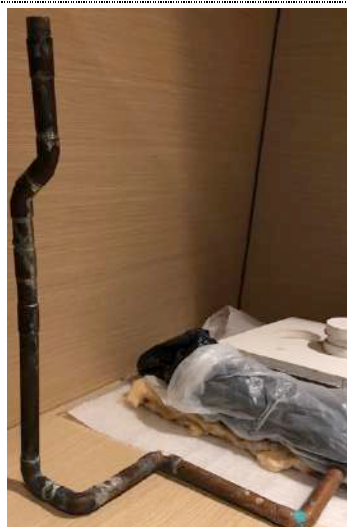
REF: 160620-3

Pipework quality – sub-standard & leaked

To find pipework installed like this is very concerning as most of the pipework cannot be observed now.

Suggest extended warranty is given above the latent defect period for all copper pipework

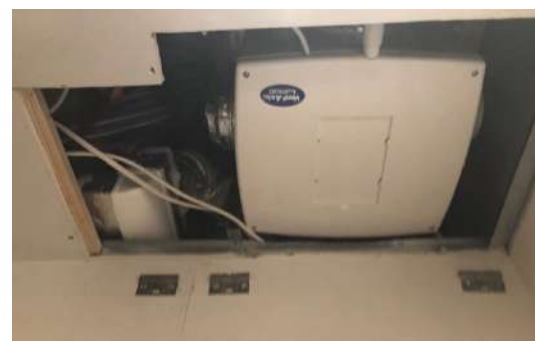
REF: 160620-4

Basement WC Fan – to be relocated

How will the circular to plastic rectangular connection be made professionally? Suggest circular duct taken through the utility room into the Equipment Store as TSA Report c/w fire damper and silencers.

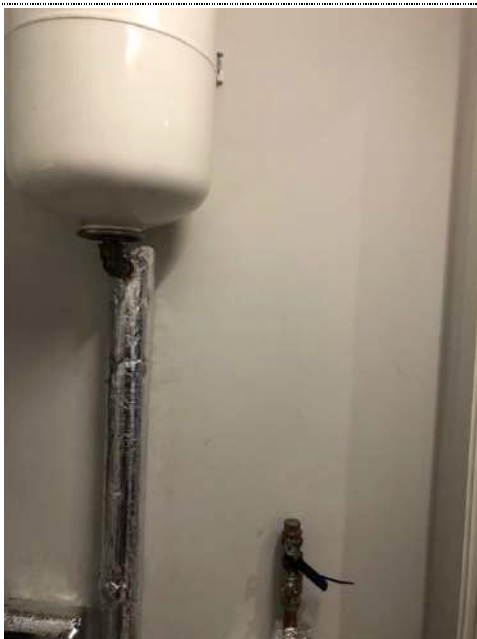
REF: 160620-5
Heating Expansion Vessel
Is this where it will be located?
See also REF: 300620-6

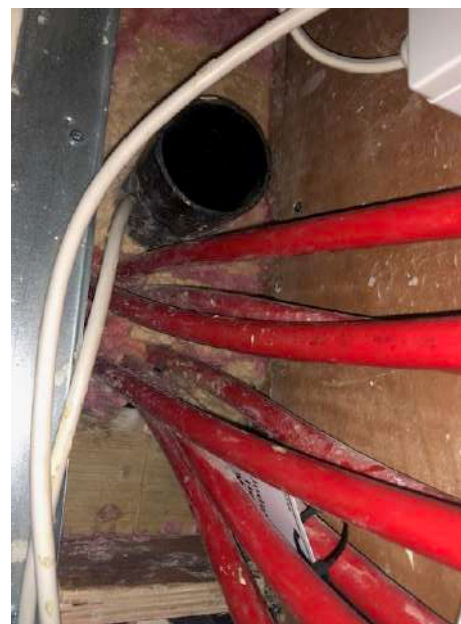
REF: 160620-6
Fire stopping: There is no vertical fire stopping within the main stairwell and as a consequence the whole house is sprinklered. Building Control to confirm that no additional fire stopping is required within the risers

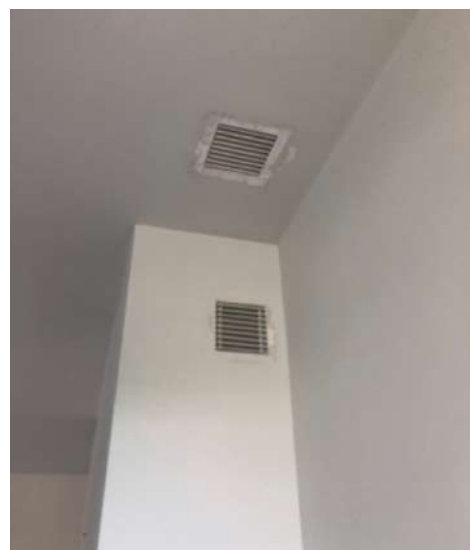
REF: 160620-7
Flue access
Vertical grille in chimney should be an access panel

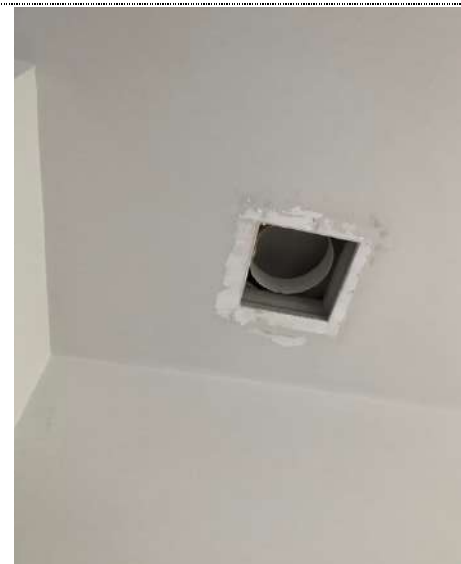
REF: 160620-8
Gas fire natural ventilation
How is the duct connected to the external air brick? Does it penetrate the cavity & physically connect by a plenum box?
See also REF: 300620-9

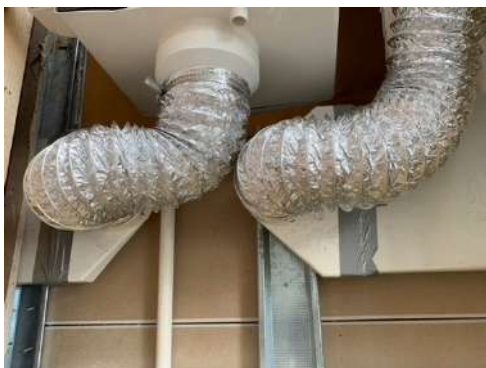
REF: 240620-1

PVC Ductwork not sealed. The life expectancy of ductwork is c50 years+ The adhesive on the tape will dry out and the tape will fall off in time. Break the joint, add sealant then re-assemble and use PK Screws & washers to ensure the joint can never come apart

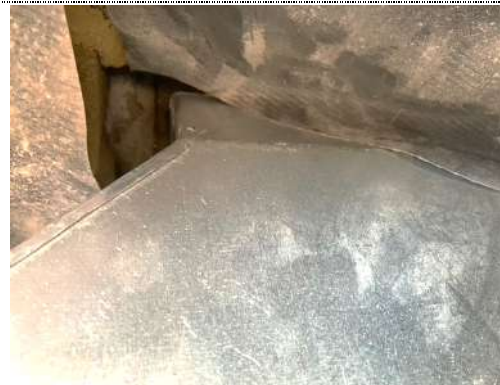
REF: 240620-2

Duct termination unclear. The bathroom extract serves 2 bathrooms so regulations state >15 l/s each. The duct needs to terminate in a weather louvre not the cavity

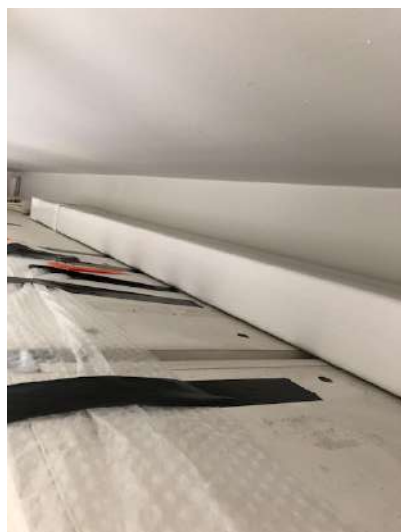
REF: 300620-1

Kitchen duct needs support clamps

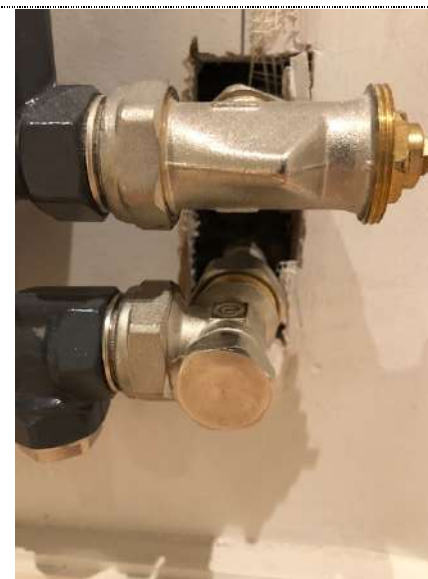
REF: 300620-2

All holes in any wall must be filled to stop insect ingress

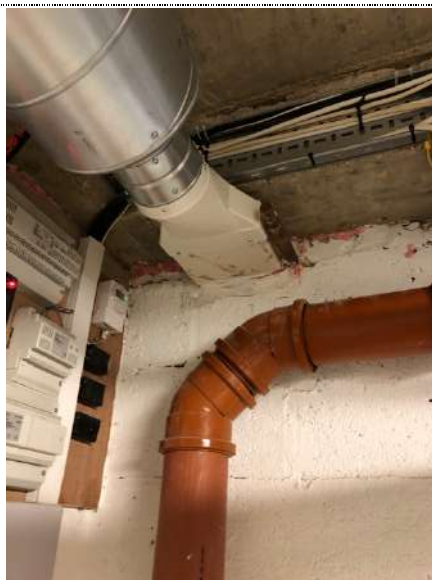
REF: 300620-3

Fire damper missing

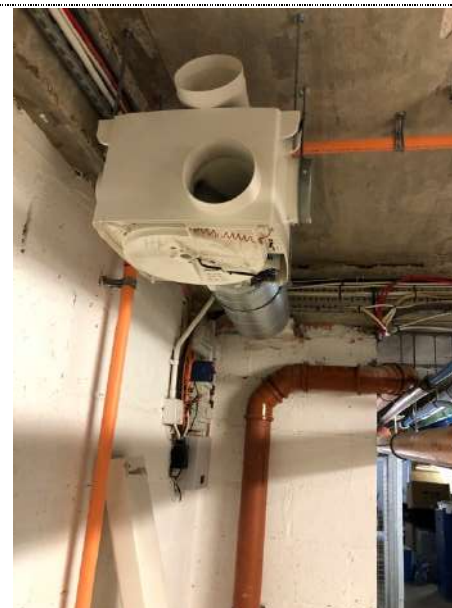
REF: 300620-4

Re-use of existing fan: Airflow rates will need to be measured to ensure Part F Building Regs flow rates are achieved

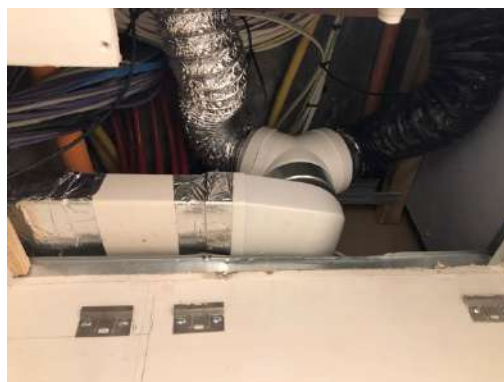
REF: 300620-5

Ductwork jointing. All PVC duct joints to be sealed, secured with 10mm screws then taped to ensure longevity.

Ductwork quality: Although PVC is a cheaper solution sheet metal ductwork has a longer life expectancy. The industry standard would have the 2 flexible ducts connecting into a galvanised header duct which would pass through the wall to the undercroft c/w a fire damper

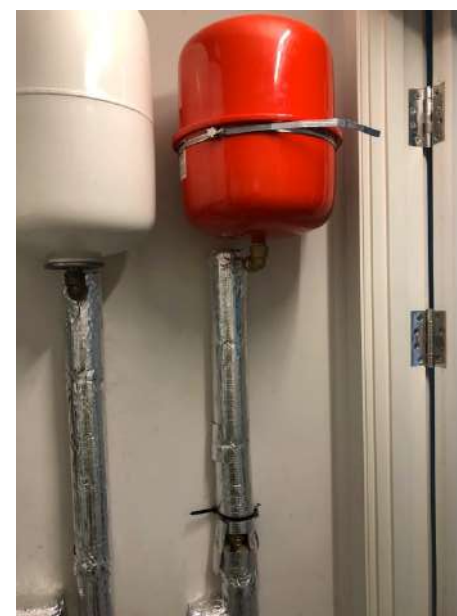
REF: 300620-6

Cut tails from jubilee clip

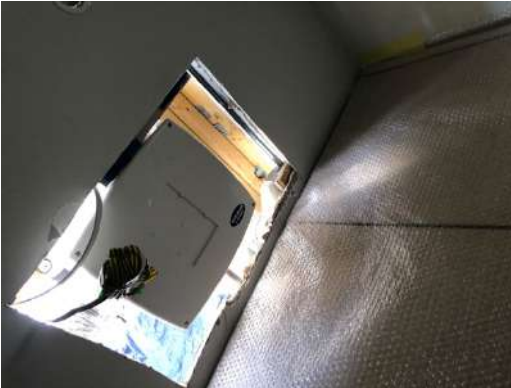
REF: 300620-7

The fan doesn't really fit as is too high protruding into the space.

Re-use of existing fan: Airflow rates will need to be measured to ensure Part F Building Regs flow rates are achieved

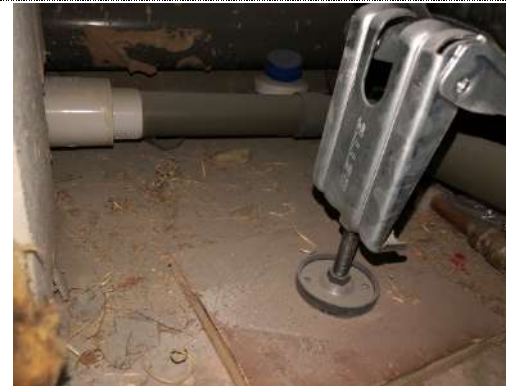
REF: 300620-8

Report of gurgling WC flush from 2nd floor bathroom. Need more access into corner to investigate

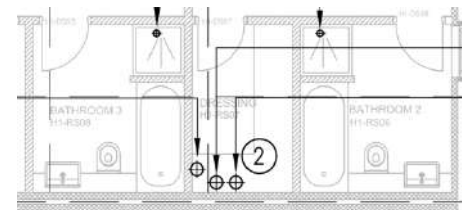
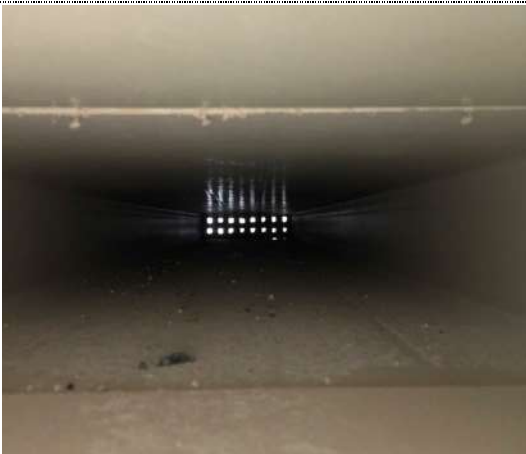
REF: 300620-9

1st Reception fireplace vent duct does terminate through wall.

RESOLVED

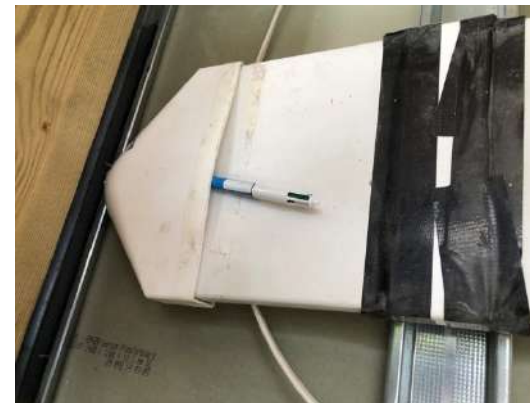
REF: 300620-10

Ductwork jointing. All PVC duct joints to be sealed, secured with 10mm screws then taped to ensure longevity.

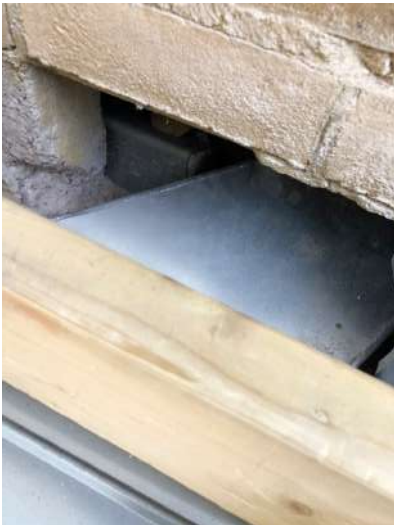
REF: 300620-11

2nd floor bathroom vent duct to terminate via weather louver not into the cavity

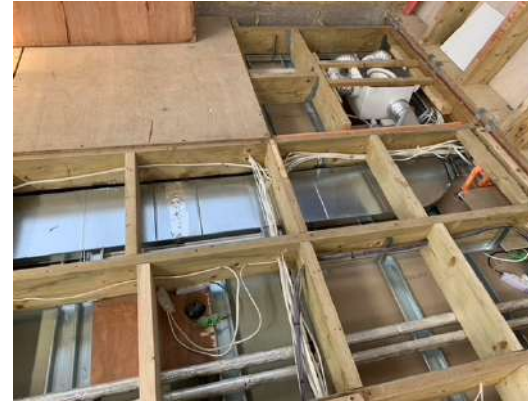
REF: 300620-12

2nd floor air venting. The pipework needs small vent line plus needle valve in accessible location, possibly in fan hatch, to facilitate air venting at top of pipe run

Ditto 2nd floor drop to radiator
